COMBINED FIRE AND HEALTH & SAFETY RISK ASSESSMENT.

Address of premises:	28 Newport Street/ 11 Station Approach, Swindon, SN1 3DX
Responsible Person:	Newport Street (Swindon) Management Company Limited
Duty Holder:	Block Management Ltd
Person(s) consulted:	No occupier or other relevant person available to consult.
Assessor:	Rob Cockburn
Report validated by:	John Godfrey, GIFireE.
Date of fire risk assessment:	5 th March 2025/ Reviewed March 2026
Date of previous fire risk assessment:	14 th March 2023
Suggested date for review:	March 2027

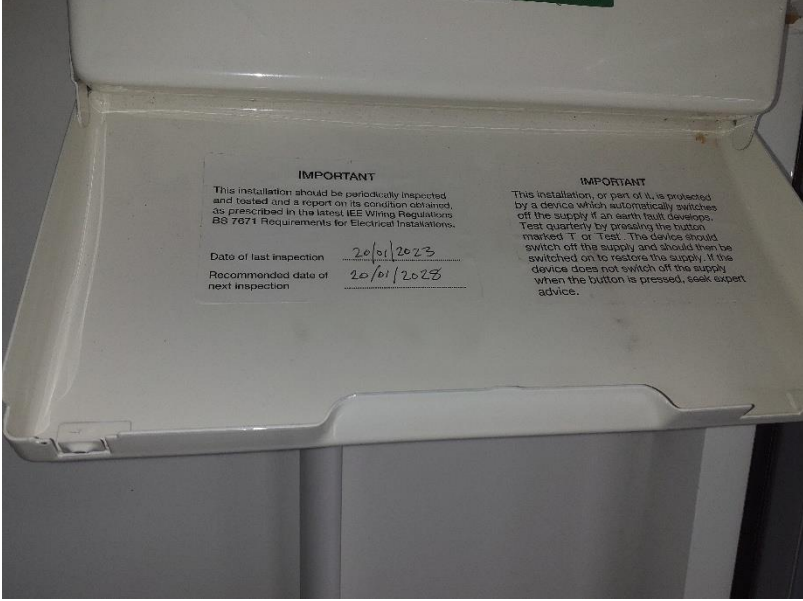
Item	Recommendation	Priority	Timescale	
01	<p>It is recommended that the client obtain a copy of the commercial units fire risk assessment under Article 22 of the Regulatory Reform Order (Fire Safety) 2005. The fire risk assessment should include comment on the suitability of the fire separation between the commercial unit and the residential units to enable proper consideration of the evacuation strategy for the residential units that form part of this assessment. The findings of this fire risk assessment should therefore be made available to the client as a priority.</p>	2	B	Action required FRA has been requested
02	<p>According to the sticker attached to the consumer unit, the fixed electrical installation was last inspected and tested in January 2023. All fixed electrical installations supplying the communal areas of a residential property should be inspected and tested by a competent person every five years in accordance with Electricity at Work Regulations / IEE Wiring Regulations Eighteenth Edition 2019 / British Standard 7671: 2018 and a written Electrical Condition Report (EICR) obtained. It is recommended that the RP create a management action to ensure the electrical installation is retested on a five yearly rolling basis.</p>

3	C	Ongoing action required DH maintain central record of EICR due dates Next due 2028

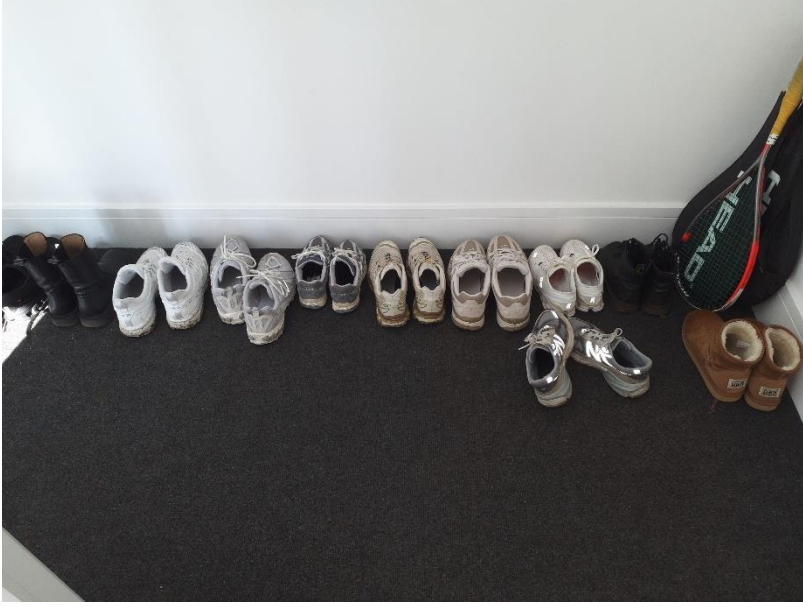
<p>04</p>	<p>Housekeeping within 1-2 11 Station Approach was found to be of a poor standard at the time of this assessment with the communal areas and escape routes congested with residents' possessions and storage. It is recommended that the client arrange for the communal areas to be cleared as a priority and all residents reminded of the importance of maintaining sterile communal areas and escape routes.</p>

<p>2</p>	<p>C</p>	<p>Ongoing action required</p> <p>DH inspect communal areas and ticket items for removal. Residents are reminded of sterile area policy via notice board</p>
<p>05</p>	<p>All contractors employed by the client must supply risk assessments and method statements prior to working. It is recommended that the client give all contractors induction training prior to commencing work, which should include emergency procedures. Additionally, the client should arrange to conduct a post work inspection of the work area to ensure all works have been completed satisfactorily and safely, with no residual hazards present that could compromise the fire safety of the premises.</p>	<p>3</p>	<p>C</p>	<p>Ongoing action required DH action as required</p>

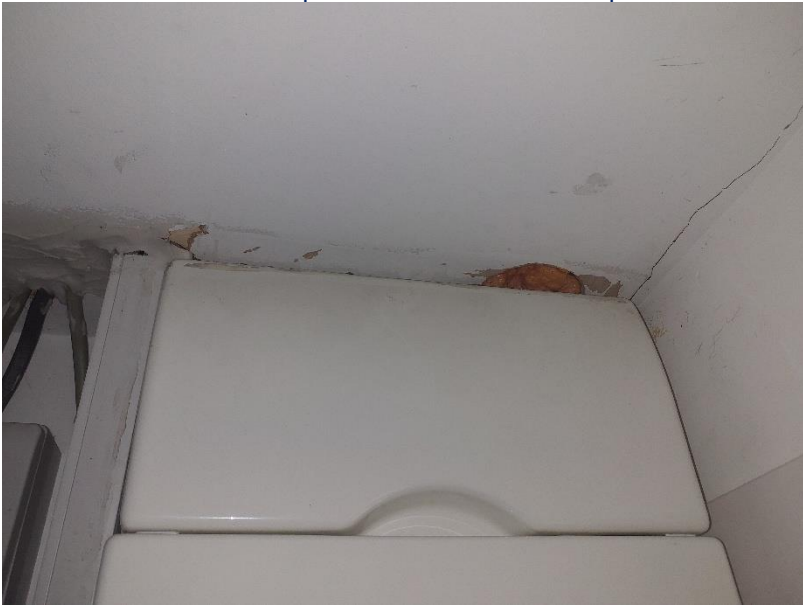
<p>08</p>	<p>It was noted during this fire risk assessment that there was an excessive use of pink foam by the fuse box within the communal area of Newport Street on the ground floor. Pink foam is to be used only as a sealant as the integrity of the pink foam cannot be confirmed when used to fill large breaches due to the changes in viscosity. It is therefore recommended that the RP instructs a suitably qualified and competent contractor to repair the breach with a suitable compound capable of providing a minimum of 30 minutes fire resistance in order to protect the means of escape.</p>

<p>2</p>	<p>B</p>	<p>Action complete Contractor has reviewed with no further concerns raised.</p>
<p>09</p>	<p>It was noted during this fire risk assessment that battery powered smoke detectors were installed within 1-2 11 Station Approach. This could be considered as an overprovision for this purpose-built block of flats implementing a stay put evacuation policy. Consideration could be given by the RP as to their removal. This is in line with current fire safety guidance for purpose-built flats.</p>
